Advanced Home Inspection Services
3388 Orcutt rd.
Santa Maria, Ca 93455
(805) 934-8486 Fax (805) 934-8444

Report #: SAMPLE

Subject Property:

1111 Anywhere St.
San Luis Obispo, Ca 44011

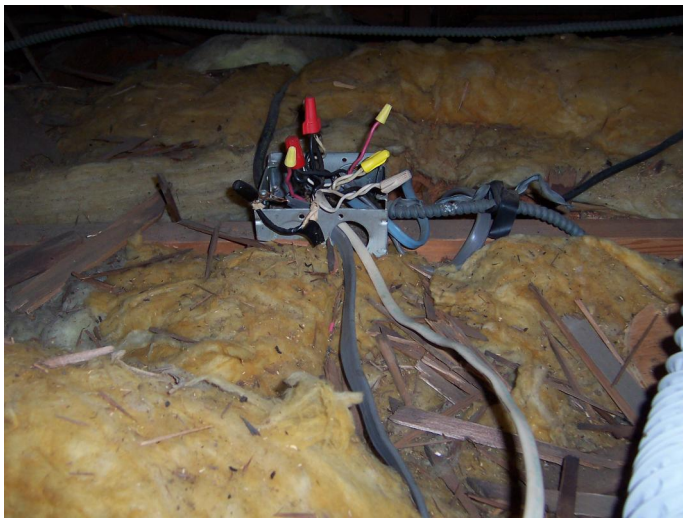
attic/wiring

Improper wiring/exposed splices noted in attic space. Repairs recommended

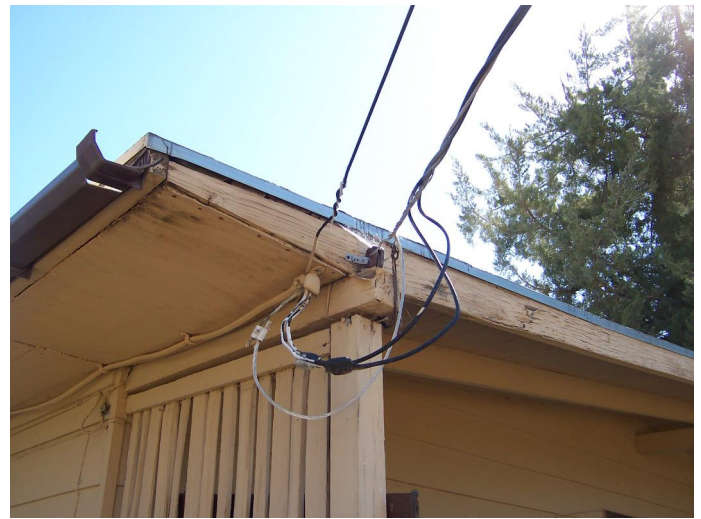
Main overhead power line connection point is below roof line. Recommend masthead installation to raise lines to proper height above structure.

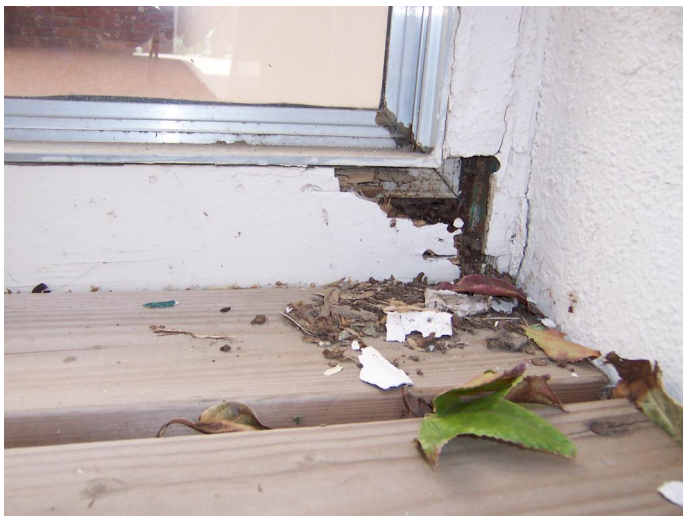
Exterior walls

Deterioration noted at rear patio and front entry. Maintenance/repairs recommended.

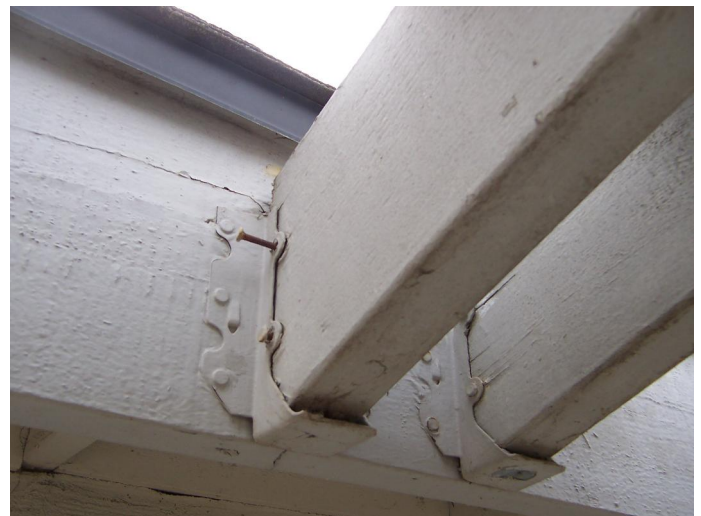
Patio cover

Loose fasteners noted at rear patio cover. Maintenance/repairs recommended.

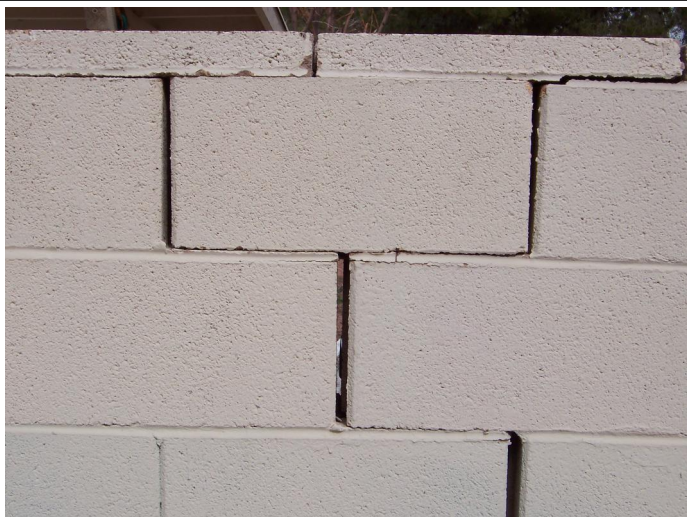
fences and gates

Loose block and stepcracking noted at rear block wall

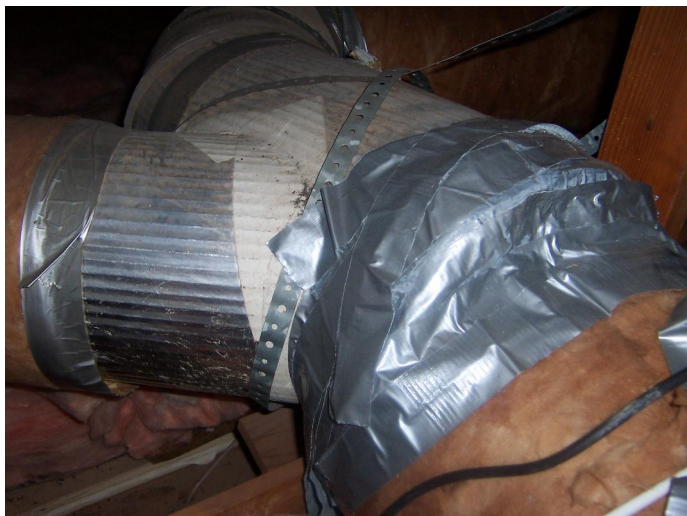
Distribution/Ducts

Improper ductwork repairs noted in attic. Maintenance/repairs recommended.

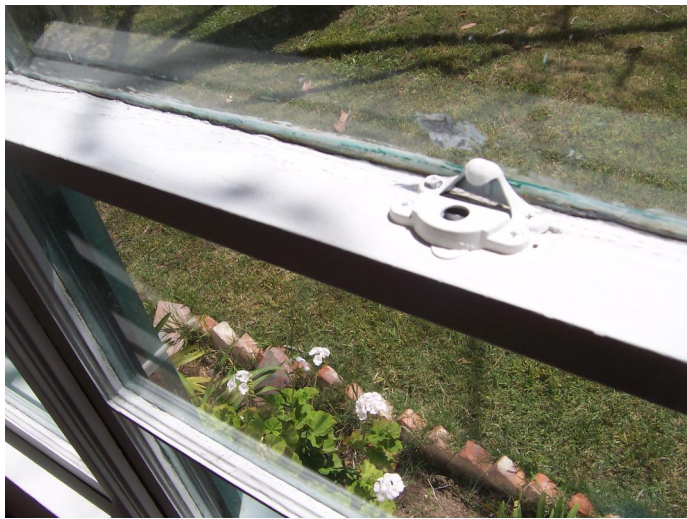
Windows

Missing/damaged hardware noted at various windows

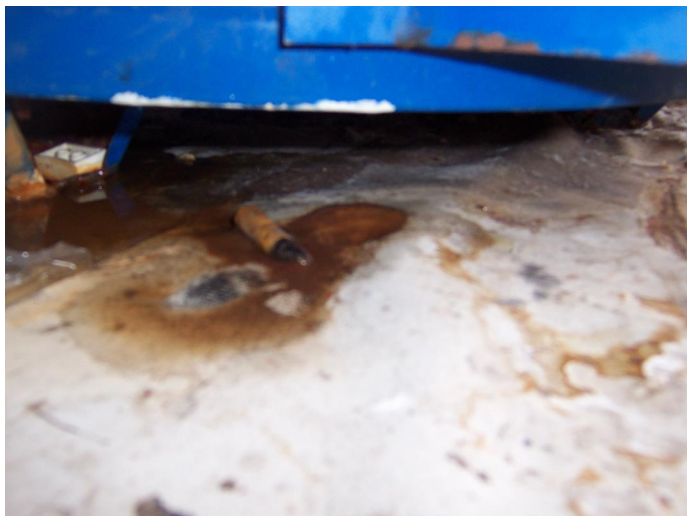
Water heater

Active leak noted at base of water heater tank

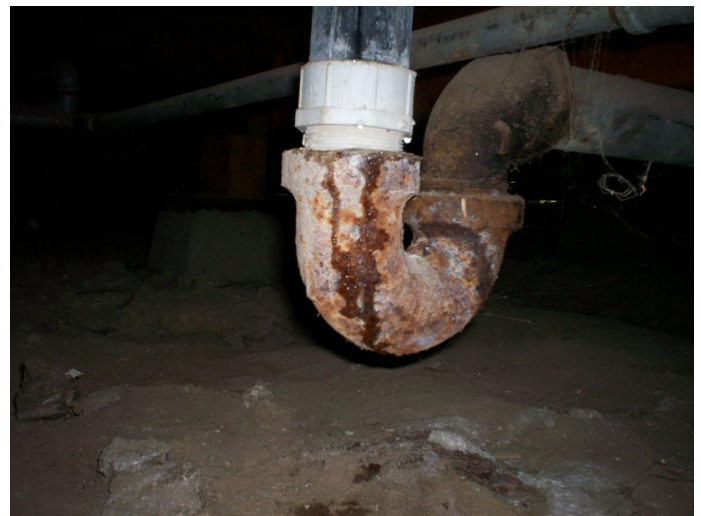
Plumbing in Crawlspace

Active leak noted at drainline below master bathroom.
Maintenance/repairs recommended

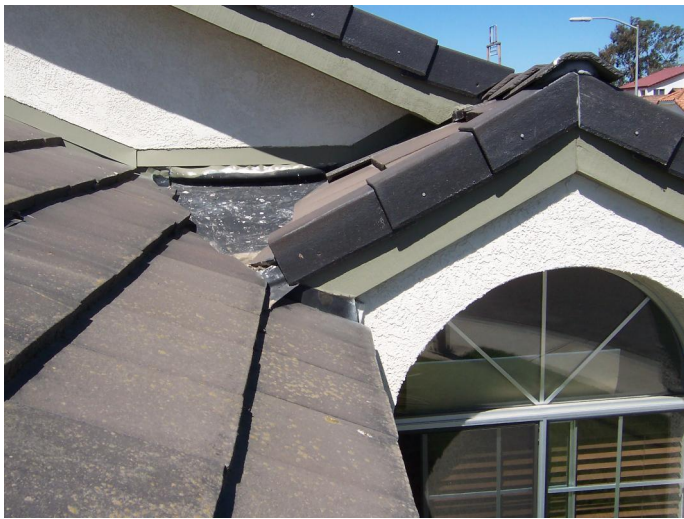
Concrete tiles

Section of roof tiles are missing above front entry. Repairs recommended.
